# VE.Bus Error Codes

## Error 8 - Ground relay test failed

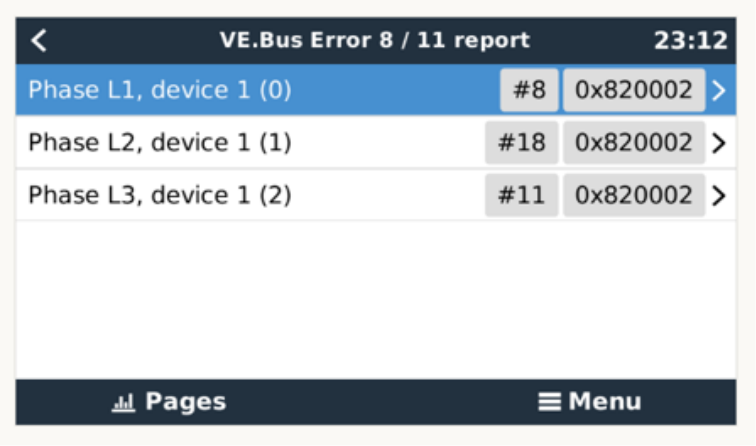
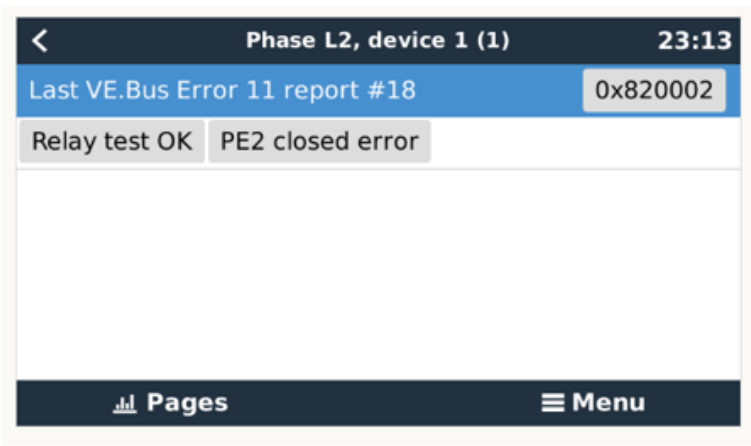
Using a GX device, the underlying detailed error can be seen for each individual inverter/charger in the system:

Definition of ground-relay related error types:

- **GND Relay Error:** Comes from the secondary controller; and can both mean that the relay is measured as being open, while it is expected to be closed, and the other way around.
- **Error: PE2 Open:** Comes from the main controller, means that the relay is measured as being open while expected to be closed.
- **Error: PE2 Closed:** Also comes from the main controller, and means that its measured as being closed while expected to be open.

Therefore, take care to analyse only the latest error: make a note of the error counter (#8, #18, #11, and so forth in the first screenshot), and then switch the system on again. And after the next shutdown, compare the actual counters with the noted counters. Alternatively, use the Download feature on the Advanced page of the VRM Portal, and analyse the data in Excel.

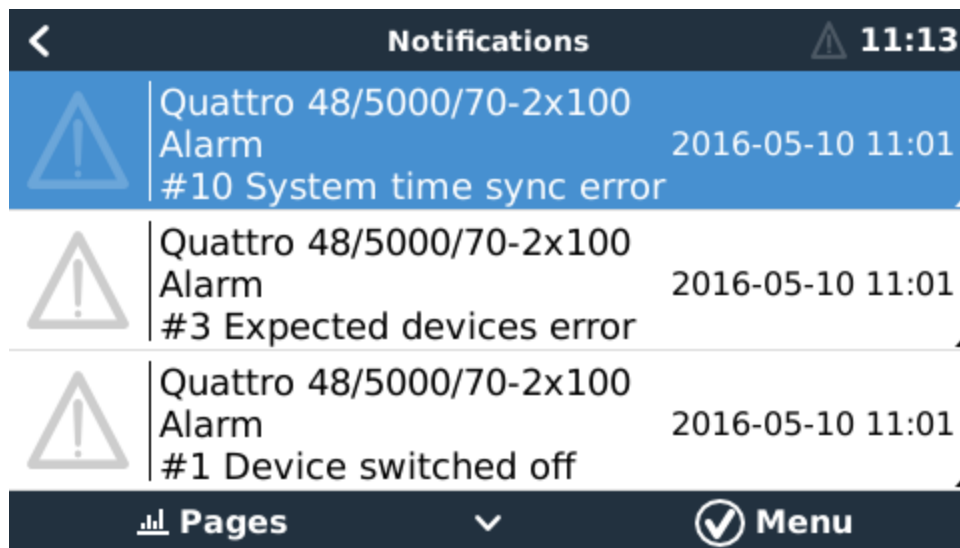
For example this screenshot from the GX device:

The real problem is Error 1. In this example it was caused by switching device L2 off with the front toggle switch. It was then quickly followed by Error 3. And when switching device L2 back on, briefly Error 10 is visible, followed by full recovery.

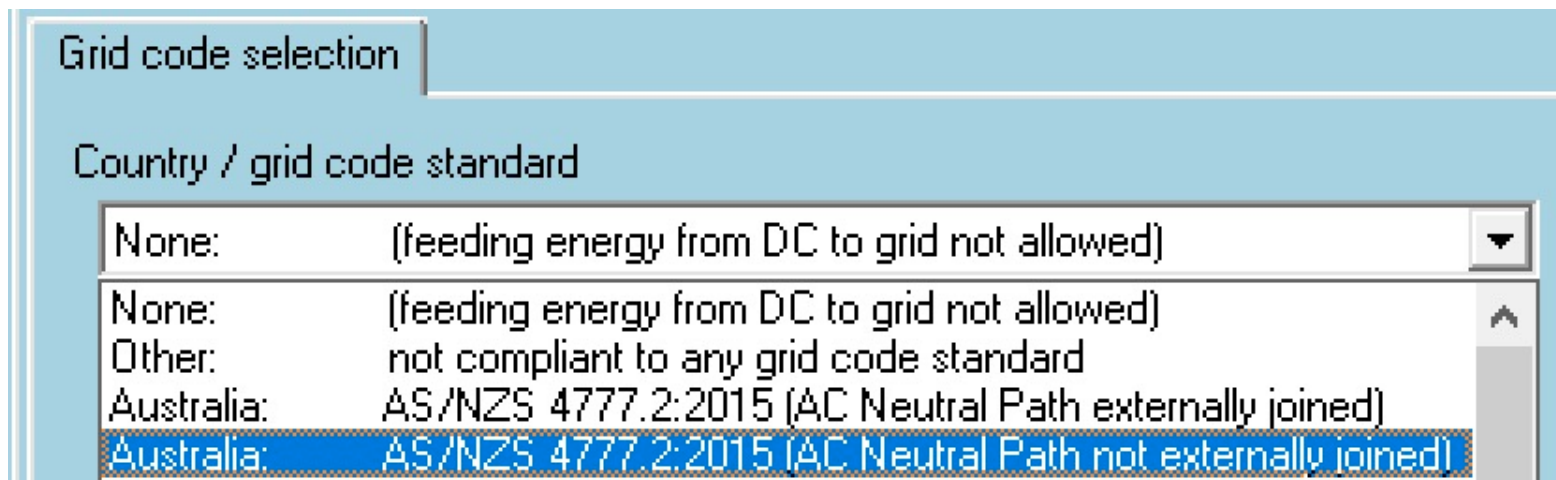
In Australia, using grid code AS4777.2:2015, it may be mandatory to make an external connection between Neutral-in and Neutral-out. Select either design configuration in the grid code section while programming the MultiPlus-II with firmware 466 or above.

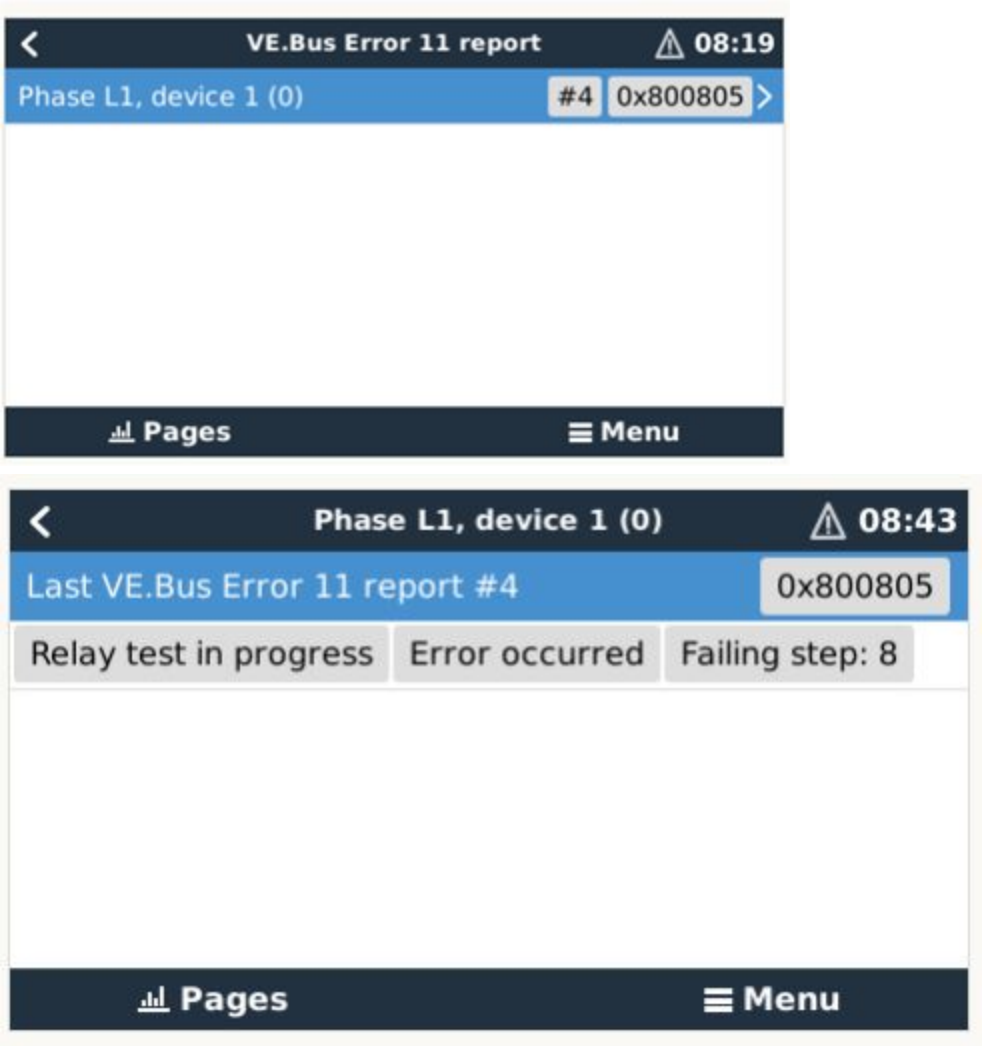
Examples of information in the GX Device menus:

The information shown is:

- A six digit number; which contains all the details
- An error ID (#4 in above screenshot). Note that this does not count the number of VE.Bus errors; its just a unique ID that can help recognizing that a new error has occurred.
- Flags
- The failed step; it counts backwards: step 9 → 8 → 7 and so forth.

After updating your VE.Bus inverter/charger to firmware 454 or higher; and running Venus OS (Operating System) v2.23 or later, a detailed VE.Bus Error 11 report is available in the GX device menu, under MultiPlus → Alarm Status → VE.Bus Error 11 report.
